**XC-142A
V/STOL TRANSPORT
TRI-SERVICE
LIMITED CATEGORY I
EVALUATION**

**TECHNICAL REPORT No. 65-27
JANUARY 1966**

**AIR FORCE FLIGHT TEST CENTER
EDWARDS AIR FORCE BASE, CALIFORNIA
AIR FORCE SYSTEMS COMMAND
UNITED STATES AIR FORCE**

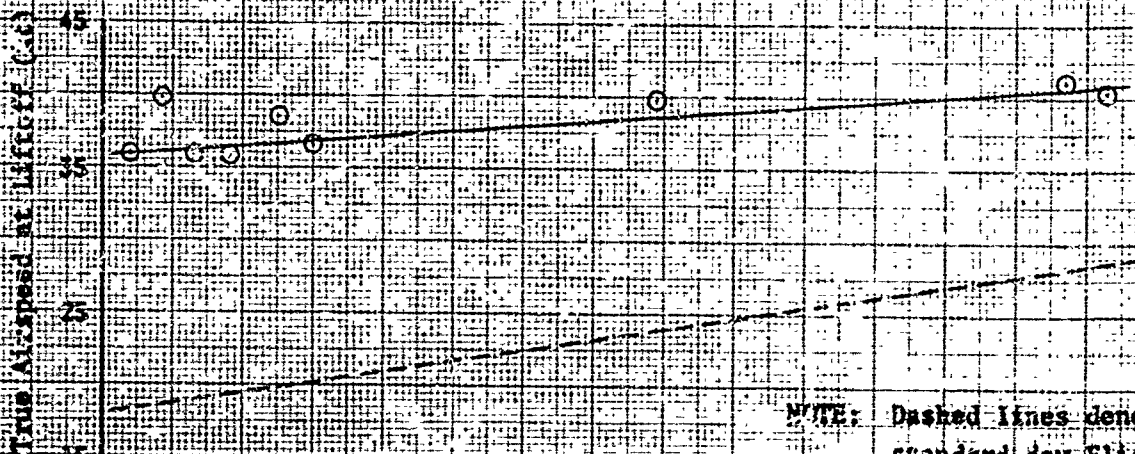
Figure 2. Takeoff Performance

XC-142A USAF S/N 62-5923
 T64 GE-1 Engines 2FE1/A3-4A Propellers
 35° Wing Incidence 50° Flaps Test Day Conditions
 Four Engines Four Propellers Operating
 93% Propeller rpm 90% Engine Torque
 2990 shp per Engine

NOTE: Dashed lines denote
 standard day flight
 manual data at 100%
 propeller rpm.

ground distances were 175 feet or less as shown in table III. During this evaluation there was not time to adequately test more than one wing angle. Therefore, all quantitative short takeoff tests were made with four engines operating, a CA of 35/30 degrees, and a cg of 18-percent MGC at weights from 34 150 to 41 300 pounds. The maximum allowable takeoff weight was 41 500 pounds. The takeoff performance data are presented in figures 2 and 3, appendix I. A 35/30 degree CA takeoff time history is shown in figure 21, appendix I.

NOTE: See figures 2 and 3 of appendix I for test conditions.
A takeoff time history is shown in figure 21, appendix I.
